Failure Analysis of a Metal Fastener

Background

Used in building interior to hold up wall system

Failed about 1 week after installation

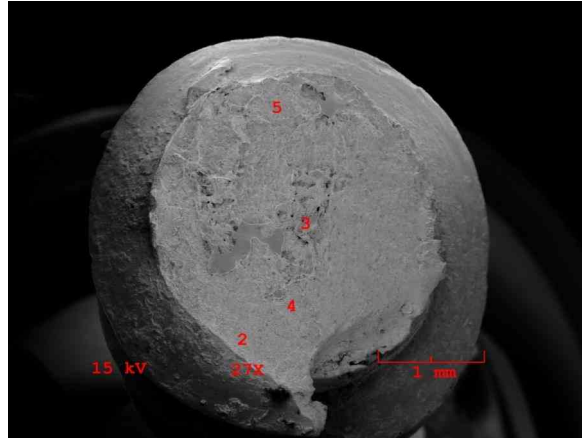
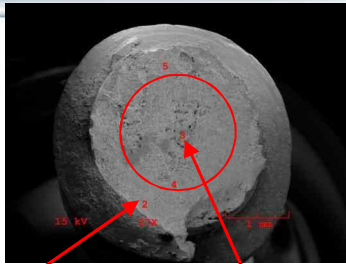
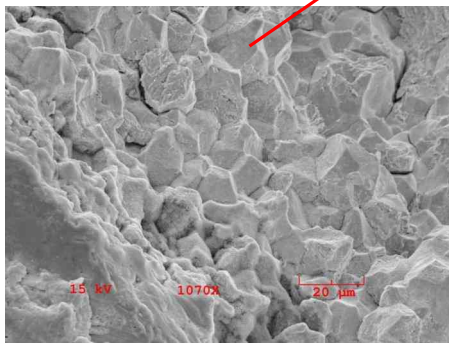
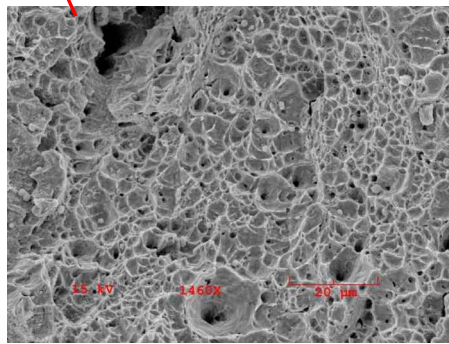
2. As cracks grew, tensile stress on intact material increased
3. Fracture occurred when stress exceeded tensile strength of intact material

1. Cracks initiated at outer surface and grew along grain boundaries

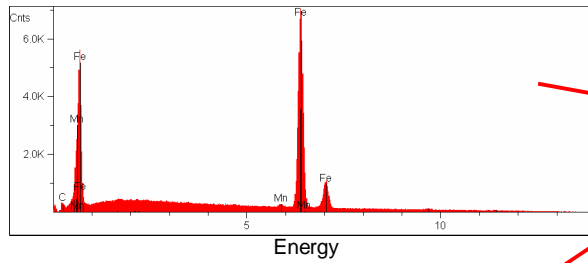
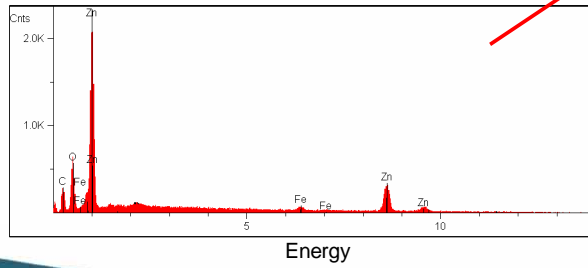
Electroplated zinc for galvanic corrosion protection

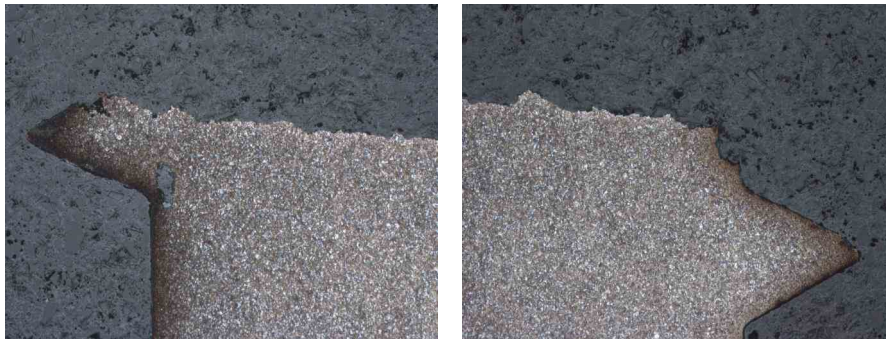
0.020 inch

Tempered martensite

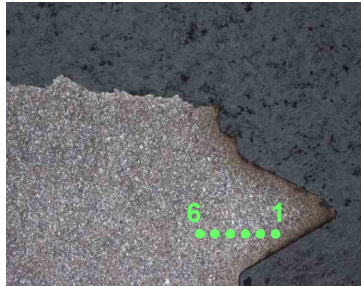
Depth from tooth surface	KHN ₅₀₀ Conversion to HRC
0.006+	45
0.012+	45
0.020+	45
Core	44/45

Through hardened, not case hardened

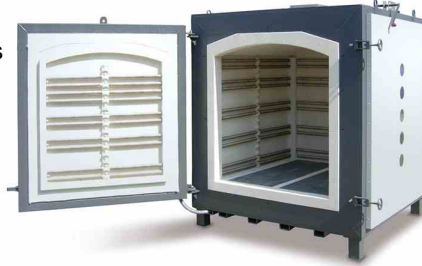
1. Intergranular cracking followed by ductile overload
2. Hydrogen embrittlement due to electroplating

3. Root cause: Insufficient or no hydrogen bake-out after plating with zinc

Bake-out required for hardened steel

- ~ Heat metal up to 400 °F for 2 to 24 hours
- ~ Hydrogen diffuses out of metal
- ~ Do within a few hours of electroplating
